# Patellofemoral Arthritis

Patellofemoral arthritis affects your kneecap (patella bone). It causes pain in the front of your knee and can make it difficult to kneel and climb stairs.

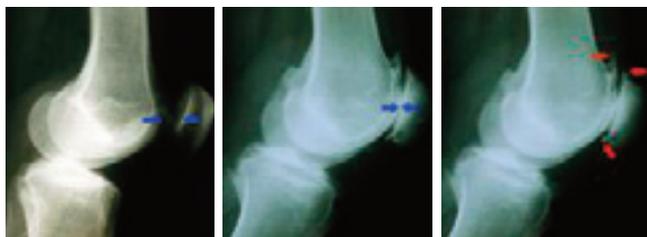
(Left) This x-ray shows a normal knee from the side. The arrows point to the normal amount of space between the bones. (Middle) In this x-ray, the arrows point to narrowed joint space due to patellofemoral arthritis. (Right) Here, the arrows point to bone spurs.

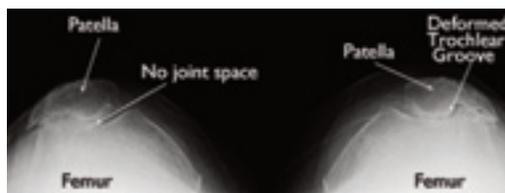
This x-ray taken from above the knee shows dysplasia that has developed into severe arthritis. There is no joint space remaining in the knee on the left. On the right, the trochlear groove has become deformed.

**Dysplasia:** Dysplasia occurs when the patella does not fit properly in the trochlear groove of the femur. Because of this, when the knee moves, there are increased stresses on the cartilage. This begins to wear the cartilage down.

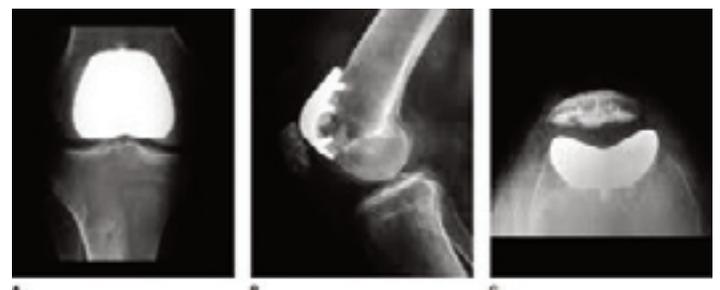
This x-ray taken shows the normal patella position after successful patellofemoral replacement. The plastic patellar implant does not show in an x-ray.

**Patellofemoral replacement:** During this partial knee replacement, worn down bone and cartilage surfaces are removed and replaced with metal and plastic implants.

The trochlear groove is covered by a thin metallic shield and a dome-like plastic implant is used on the patella. Both components are held in place by bone cement.
