Patellofemoral Arthritis

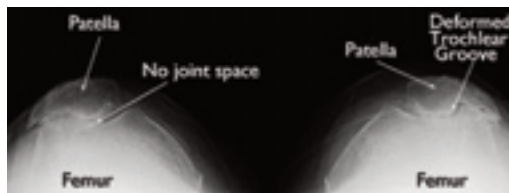
This x-ray taken from above the knee shows dysplasia that has developed into severe arthritis. There is no joint space remaining in the knee on the left. On the right, the trochlear groove has become deformed.

Dysplasia: Dysplasia occurs when the patella does not fit properly in the trochlear groove of the femur. Because of this, when the knee moves, there are increased stresses on the cartilage. This begins to wear the cartilage down.

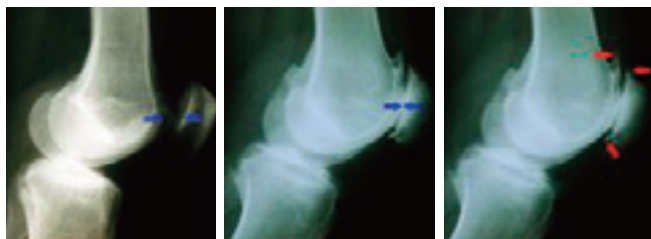
(Left) This x-ray shows a normal knee from the side. The arrows point to the normal amount of space between the bones. (Middle) In this x-ray, the arrows point to narrowed joint space due to patellofemoral arthritis. (Right) Here, the arrows point to bone spurs.

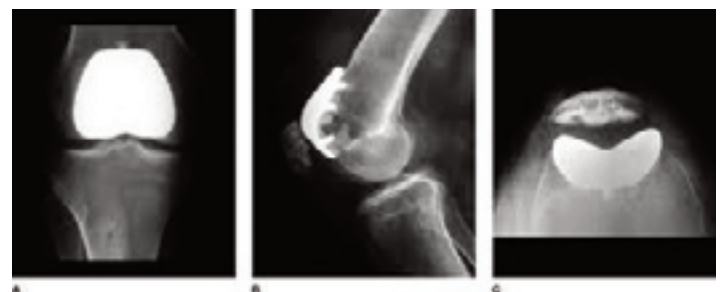
This x-ray taken shows the normal patella position after successful patellofemoral replacement. The plastic patellar implant does not show in an x-ray.

Patellofemoral replacement: During this partial knee replacement, worn down bone and cartilage surfaces are removed and replaced with metal and plastic implants.

The trochlear groove is covered by a thin metallic shield and a dome-like plastic implant is used on the patella. Both components are held in place by bone cement.
